Abrasion and Fibre Fatigue in High Performance Synthetic Ropes for Ship Escort and Berthing

Terry Crump, Kris Volpenhein, Dennis Sherman & Rafael Chou, Samson, USA

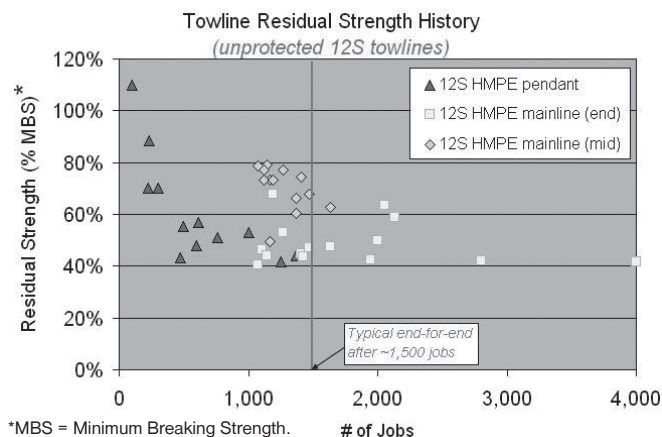
Figure 1: Residual strength history; ropes of similar sizes performing similar jobs in harbour class tractor tugs in Puget Sound and Southern California⁴.

Among all marine applications, tug assist is one of the most severe environments that a rope can experience. Comprehensive testing and field trials have been conducted, as shown in *Figure 1*, comparing residual strengths of HMPE lines against the number of jobs performed.

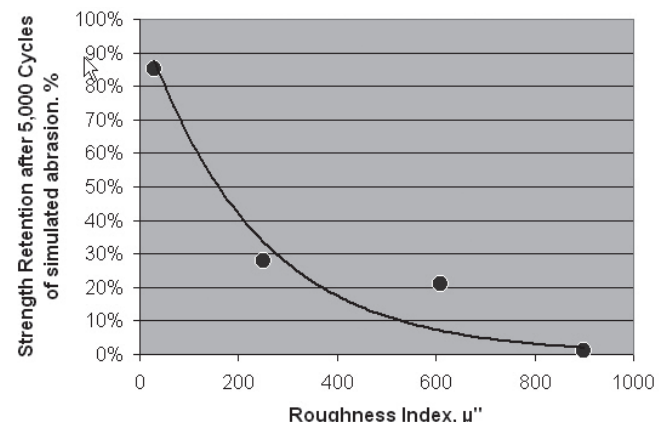
Figure 2: Surface roughness comparison^{2,3}.

In order to best protect from this unnecessary damage on board, it is recommended that surface hardware be kept at a maximum of $250 \mu^2$. This recommendation is supported with testing as shown in *Figure 2*, showing the effects of a rough surface on rope life.

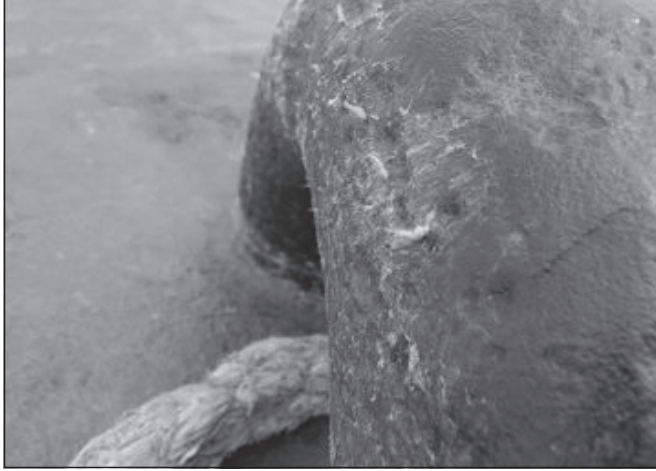
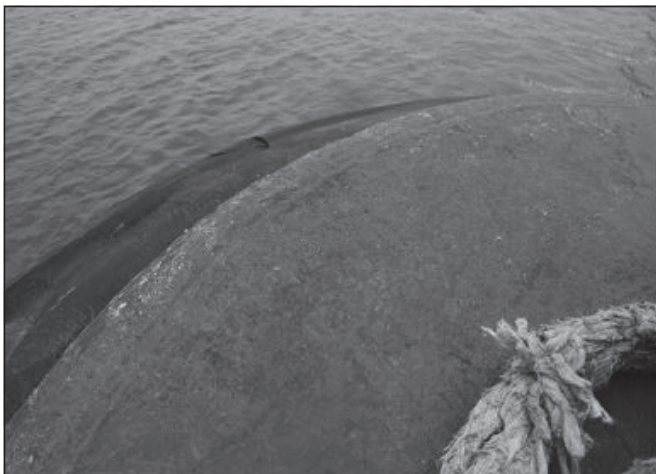
Figures 3a & b: Bull nose contact surfaces; rough surfaces causing heavy surface abrasion.

In *Figures 3a & b*, small amounts of fibre can be seen on the bull nose and lead edge of the tug where rough surfaces have worn the rope's surface.

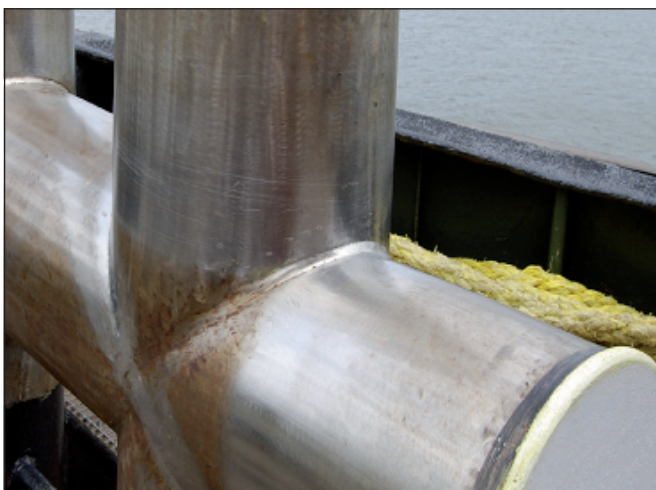
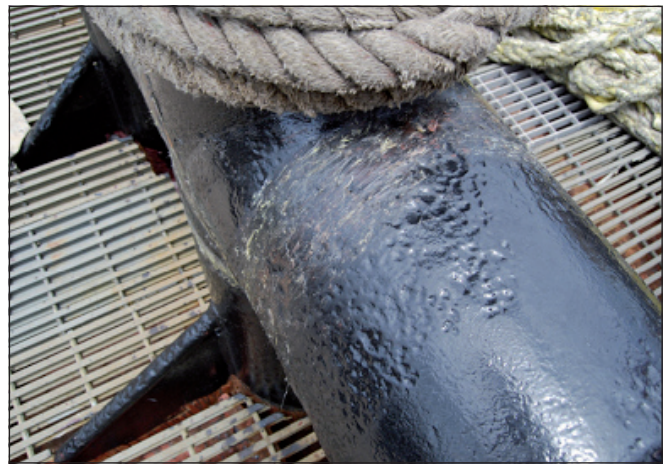
Figures 4a (below left) & 4b, above: H-bitt comparison.

Figures 4a & b, below left, and above, show a comparison of a stainless steel-clad H-bitt to a typical 'carbon steel' H-bitt. Note the differences in surface roughness and pitting. Even after being painted, these locations on the H-bitt cause a noticeable difference in the condition of the lines that are used on them.

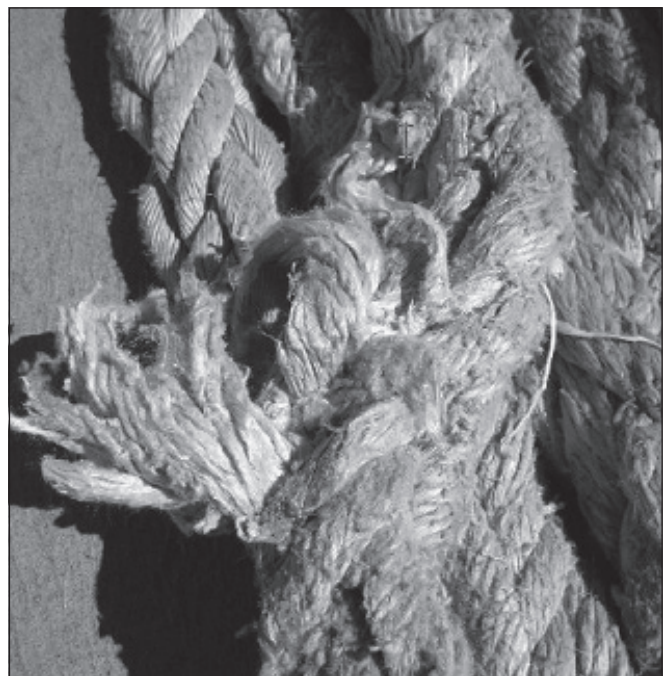
Figure 5: Cut strands.

It is highly recommended that any rope that has suffered adjacent cut strands be retired or repaired by cutting out the damaged section and re-splicing. If a cut line cannot be repaired it should be treated with caution and replaced at the earliest convenience. Figure 5 shows an eight-strand

rope with a cut strand even though the rope was in otherwise good condition with only moderate surface abrasion.

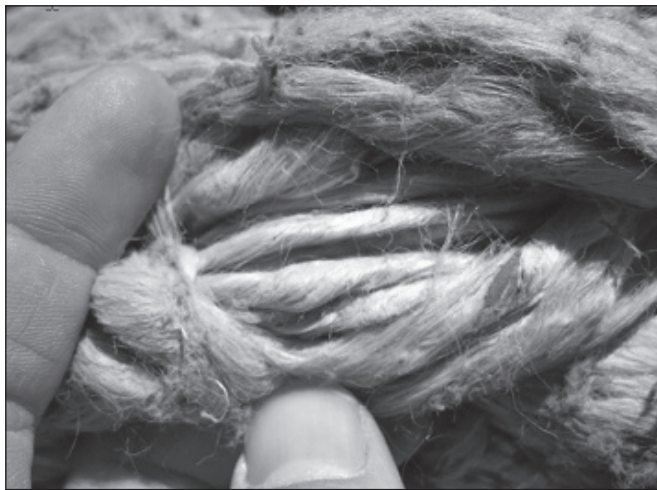
Figure 6: Comparing internal and external yarn condition.

While a rope's outside surface may look rough or damaged, it is important to compare the inner yarns to determine how much abrasion damage has affected the rope's strength. *Figure 6* shows internal yarns that are beginning to suffer from moderate internal abrasion, but are still in a serviceable condition.

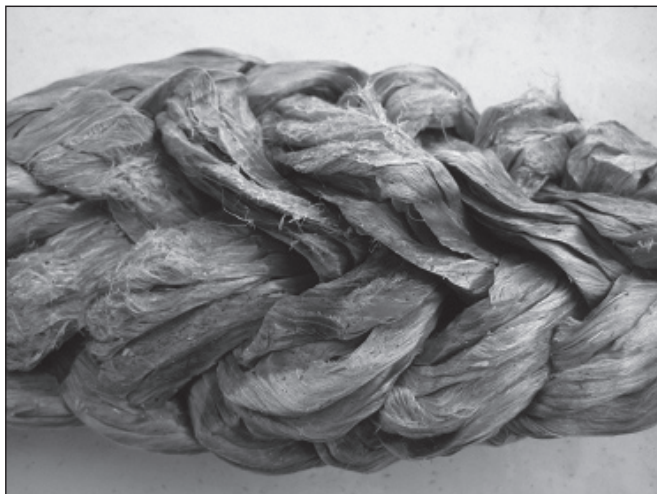
Figures 7a & b: Melted and fused fibre damage.

With any HMPE line, melting damage is a concern. Quick slipping on hardware under high loads can generate a high amount of heat that can cause yarns or even strands to melt and fuse together, as seen in *Figures 7a & b*.

The fibres/yarns will have a glossy appearance and it will no longer be possible to separate them by hand. This situation should be carefully guarded against. If the yarns

that make up a strand are found to be completely fused, that section of the rope should be removed or the entire rope retired.

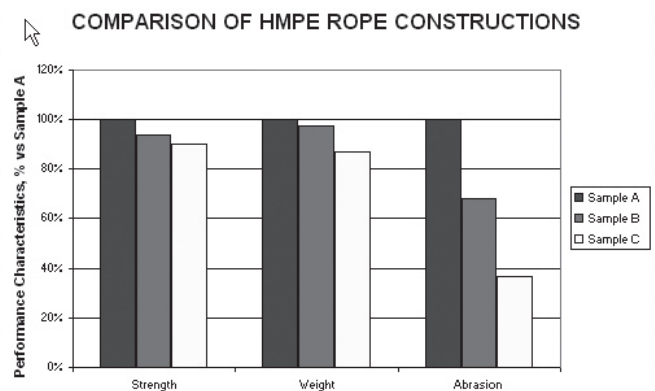
Using Sample A as the control sample, *Figure 9* shows the difference in performance characteristics between the three samples tested. Each rope was cycled in a wet abrasion environment under tension until failure occurred. While the weight and strength specifications for each rope were very similar, there was a dramatic difference in abrasion resistance. The loose braid samples had a significant decrease in their ability to resist abrasion damage.

Figure 9: Construction comparison testing.

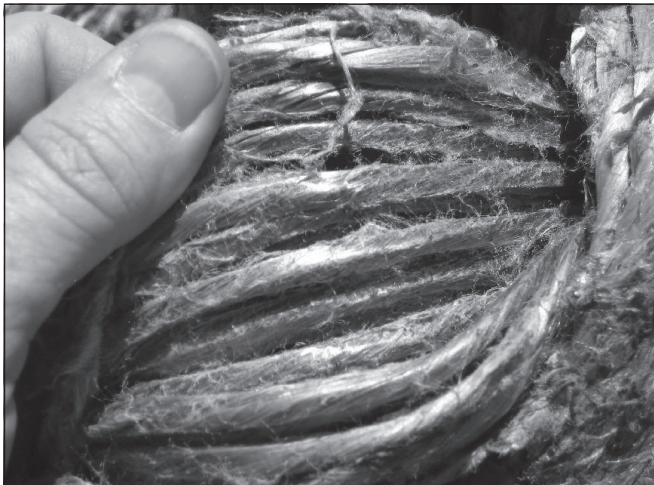
Figure 11: Example of heavy internal abrasion.

After just a few weeks in service the outside surface of any rope made from HMPE fibre will begin to look rough and 'fuzzy' (*Figure 10*). This is due to external abrasion caused by unavoidable contact with rough surfaces such as chocks and/or the vessel's deck. During service the strands of a braided rope are constantly being subjected to relative movement. This movement causes damage at the points in which strands cross each other, much like the damage caused at positions where the line crosses the chock (*Figure 11*).

Abrasion, being the dominant factor in decreasing strength and service life, consists of external and internal abrasion. *Figures 10 and 11* show examples of external and internal abrasion, respectively.

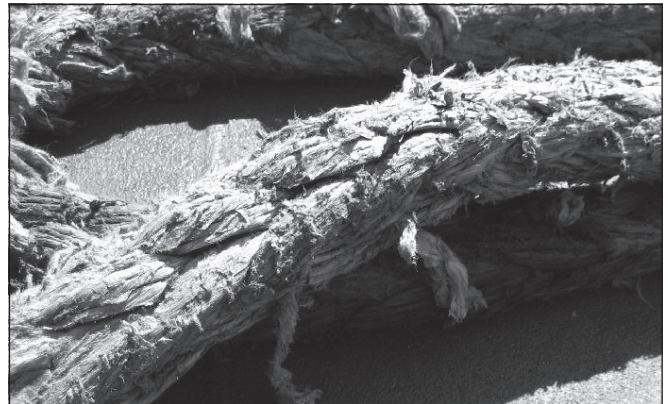
Figures 12 and 13 show the lines just below the eye splice. Although both lines show some external wear, there is more severe abrasion on the line in *Figure 13*.

Figure 13: Tug D pendant (extreme abrasion with cut strands) - without chafe protection.

Figures 12-14 represent 30m pendants taken off two nearly identical 6,000hp tractor tugs operating within the same waters after approximately the same number of jobs (Tug C: 630 jobs, Tug D: 704 jobs). The two tugs were using the same product (12-strand braided rope made of HMPE fibre) with one exception: Tug C utilised chafe protection in and around the outboard eye of the line while Tug D did not use any chafe protection on the line. Several issues should be noted upon inspection of these lines.

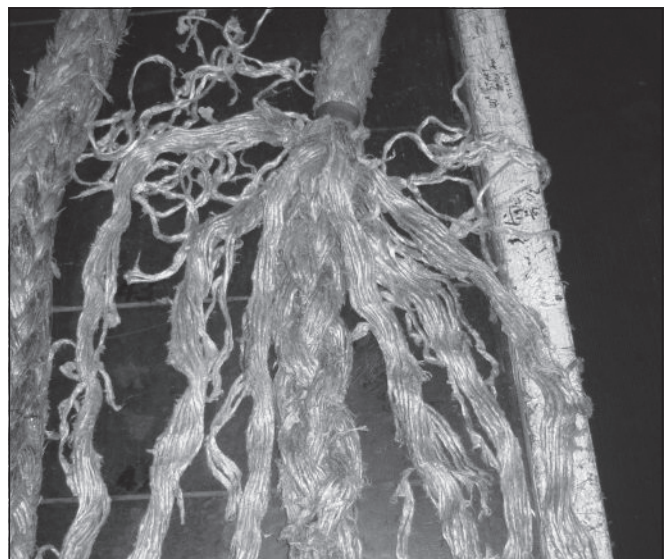
Figure 14: Tug D pendant (cut strands).

When the line from Tug D was inspected it was evident that the surface abrasion had greatly affected the condition of the rope. The abrasion damage was so severe that a majority of the rope's strands had been at least partially cut or worn through as shown in *Figure 14* (previous page), with several cut yarns from throughout the lay length of the rope.

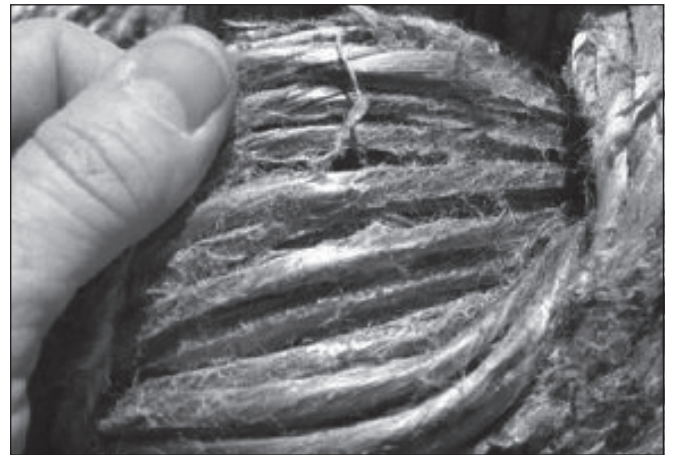
Figures 15 and 16 compare the internal abrasion of the ropes from Tug C and Tug D respectively. These images show a very important advantage to the proper use of chafe protection. While Tug C had performed over 10 per cent more jobs than Tug D, it is very clear that the chafe protection used in the eyes of the tow line on Tug C was able to greatly reduce the amount of both external and internal abrasion on the line. Looking at the internal strands of each line one can see the strands covered by chafe gear look close to new, while the unprotected strands are fuzzy and worn.

Figures 16a and b: Tug D – abrasion (without chafe protection).

All the information described above is summarised by testing to determine the residual strength of the pendants to quantify their current safety factor based on residual strength. *Table 1* shows the difference in average residual strength between the pendants off Tug C and Tug D. This difference in residual strength can be directly attributed to the use of chafe gear as well as differences in handling techniques between the two operators.

The internal abrasion damage shown above occurs from the internal 'cutting' action that takes place between strands/yarns in all braided ropes and can be limited greatly through the use of chafe protection. This phenomenon is a result of the chafe gear allowing for the entire rope to slide and adjust inside the chafe protection while the chafe gear absorbs the frictional effects from surface contact. Conversely, without chafe protection the rope's surface yarns become the contact surface with hardware. This increases the amount of relative motion between surface yarns and internal yarns and in turn increases the damage done by internal abrasion. This makes it critical to know how and where to utilise effective chafe gear in order to maximise the life of a tow line and mitigate risks involved with the application.
